# **Intel® Pentium® III Processor Specification Update**

Release Date: March 2001

The Pentium® III processor may contain design defects or errors known as errata which may cause the product to deviate from published specifications. Current characterized errata are documented in this Specification Update.

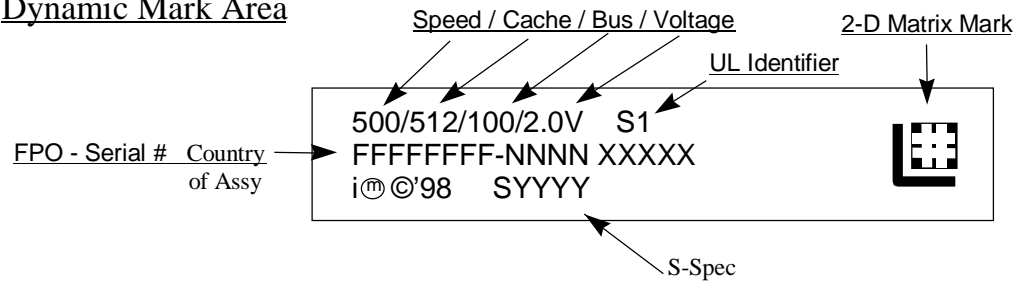
### *Pentium® III Processor and Boxed Pentium® III Processor 3 Line Markings*

#### Dynamic Mark Area
